DESIGN AND CONSTRUCTION OF FABRIC REINFORCED  
RETAINING WALLS BY NEW YORK STATE

Gary E. Douglas, Senior Soils Engineer  
Soil Mechanics Bureau  
New York State Department of Transportation  
1220 Washington Avenue  
Albany, New York 12232

This paper relates the experience of New York State in the design and construction of two fabric-reinforced retaining walls. Crushed stone fill is reinforced by horizontal layers of fabric placed at intervals dependent upon the height of the wall, the strength of the fabric, and the internal friction angle of the fill. Design and construction procedures are detailed, with emphasis on practical construction techniques.

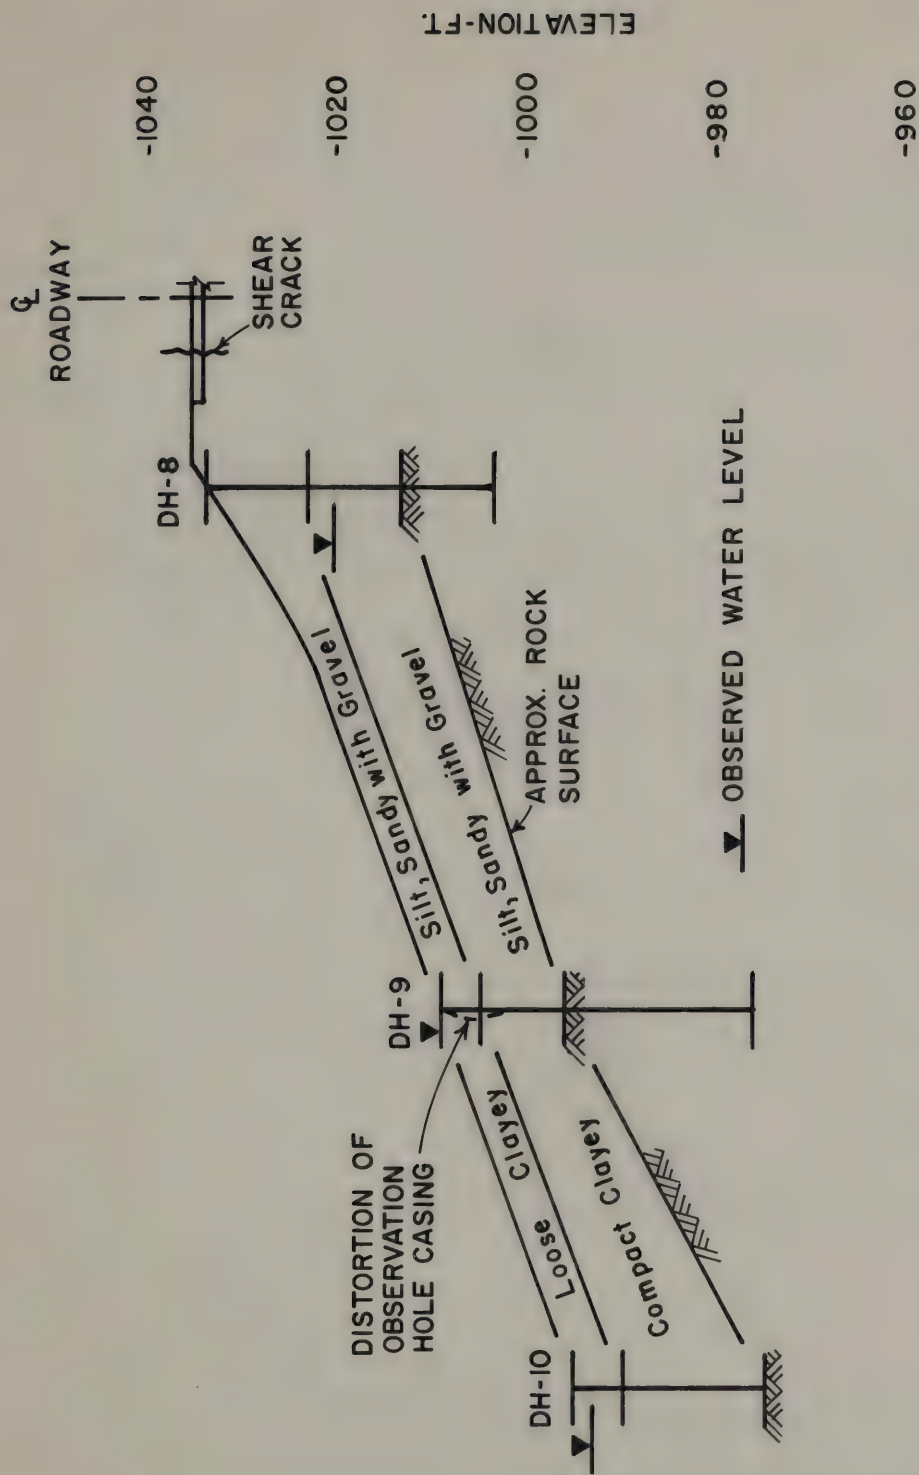
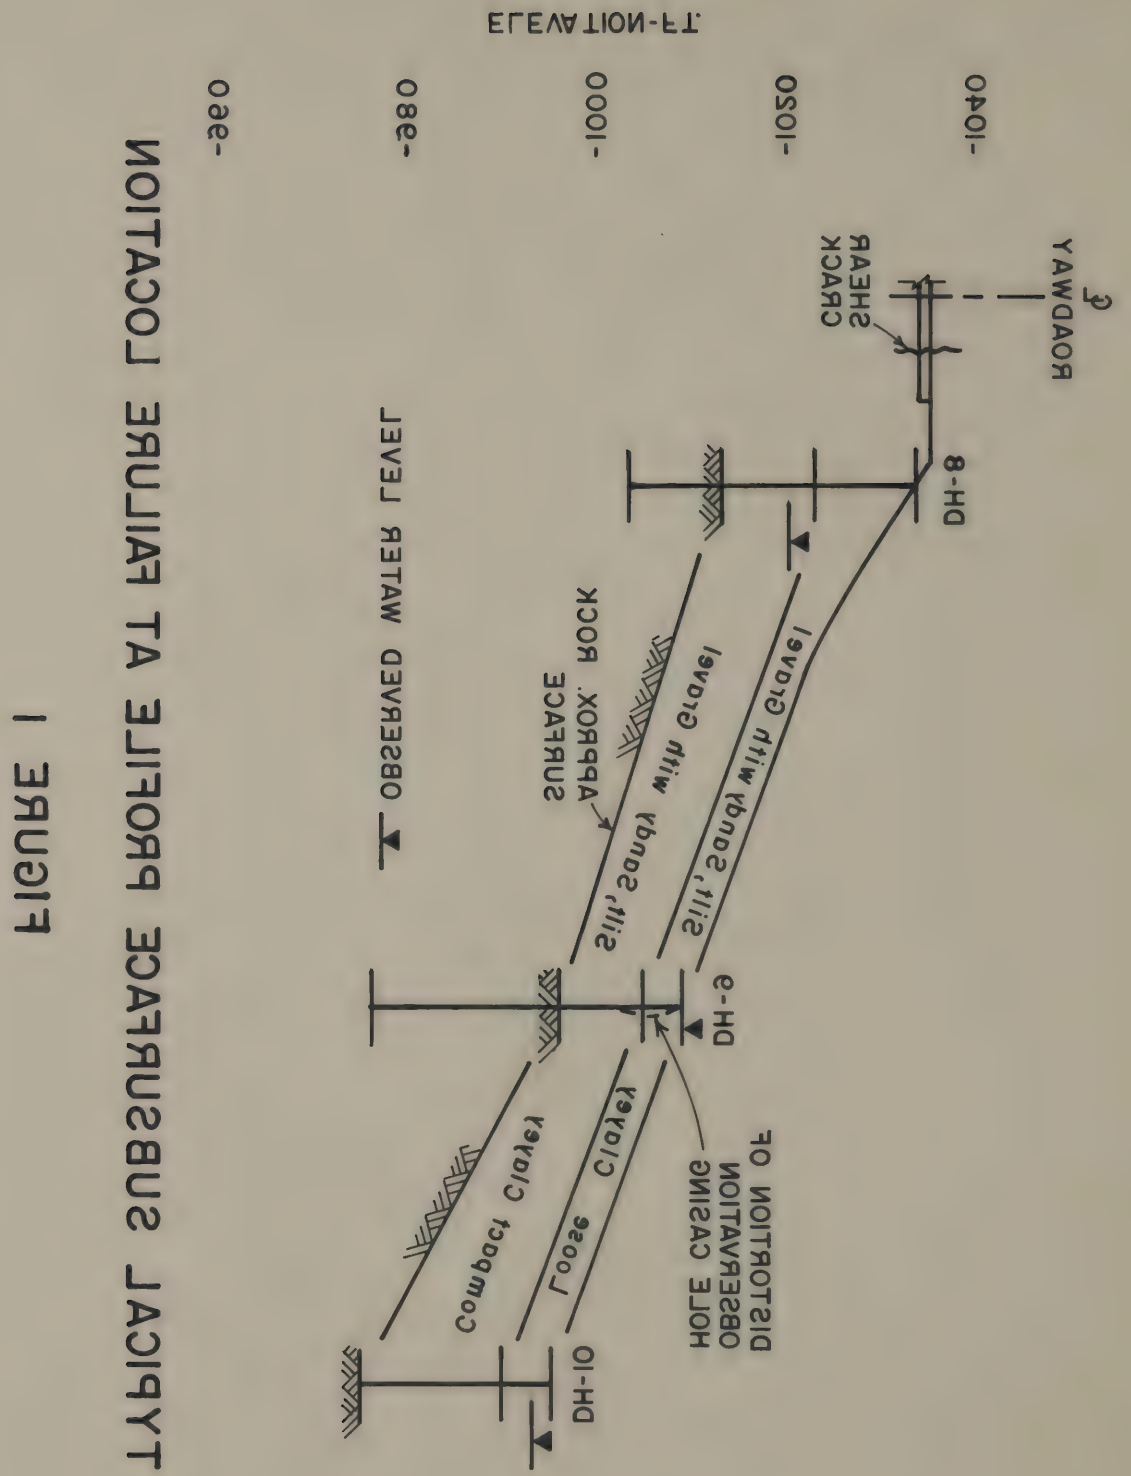
FIGURE 1

Movements up to 0.2 feet horizontally and 1.2 feet vertically, detected from 9/76 to 4/78, and distortion of observation hole casing at depths of 4 to 5 feet (see Figure 1), indicated a shallow failure in the loose material rather than a sliding failure along the rock surface. Subsurface water, due to sidehill seepage at Area B and a broken box culvert at Area A, was the primary cause for failure of the 1 vertical on 1-1/2 horizontal embankment slopes. This assumption was supported by the existence of 125 feet of unaffected 1 on 1-1/2 slope between the two failure areas, and the natural flattening of slopes in the wet areas to 1 on 2.5.

TYPICAL SUBSURFACE PROFILE AT FAILURE LOCATION

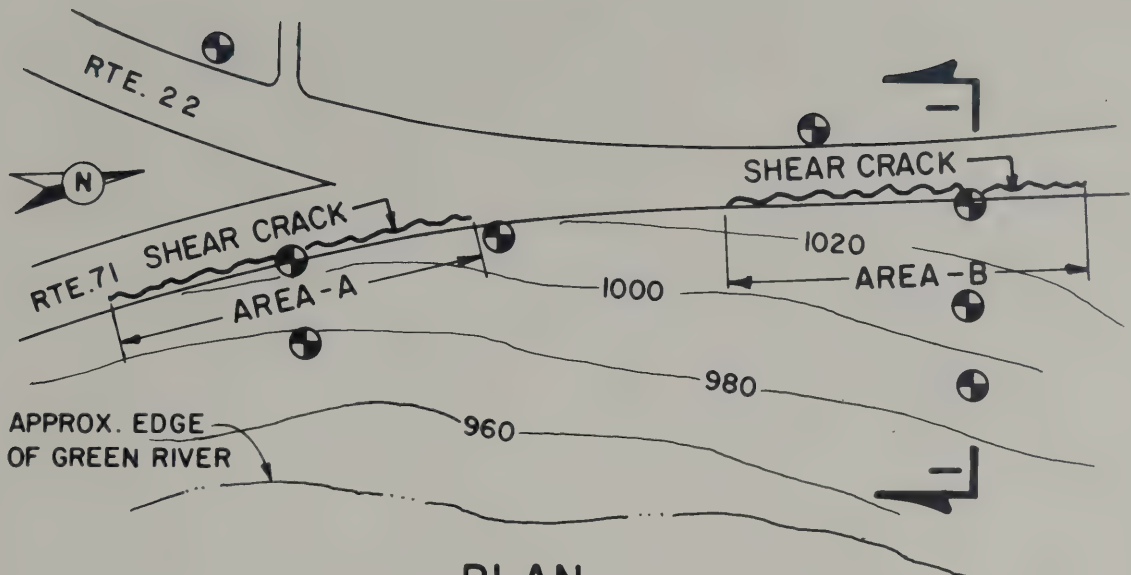
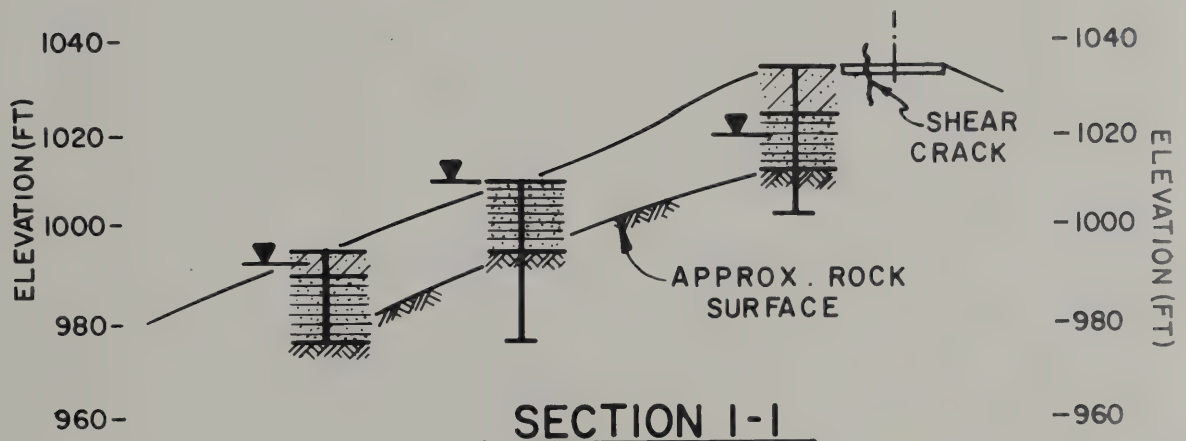
FIGURE 1

FAILURE LOCATION  
AND TYPICAL SUBSURFACE PROFILE

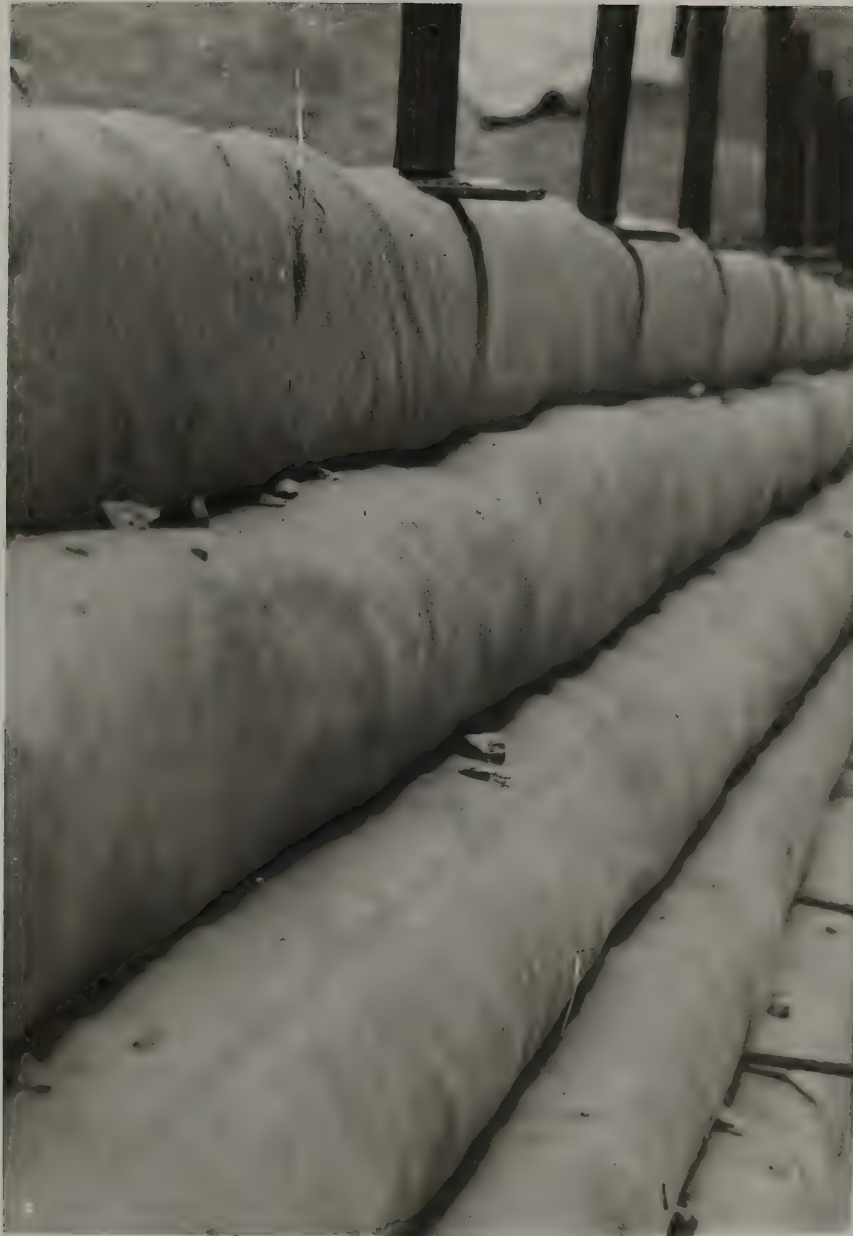
was desired at the wall face, to minimize post-construction settlements and horizontal movements in this area. However, the specified minimum of four passes was reduced to two passes, when observations showed the compaction effort was penetrating several underlying lifts. After the form was removed, the vertical face gradually became curved as overlying lifts were compacted. Even when thoroughly compacted, the fabric at the face did not appear highly stressed, and could actually be pinched by ordinary finger pressure.

WALL FACE SHOWING EFFECTS OF  
COMPACTION ON UNDERLYING LIFTS  
FIGURE 12

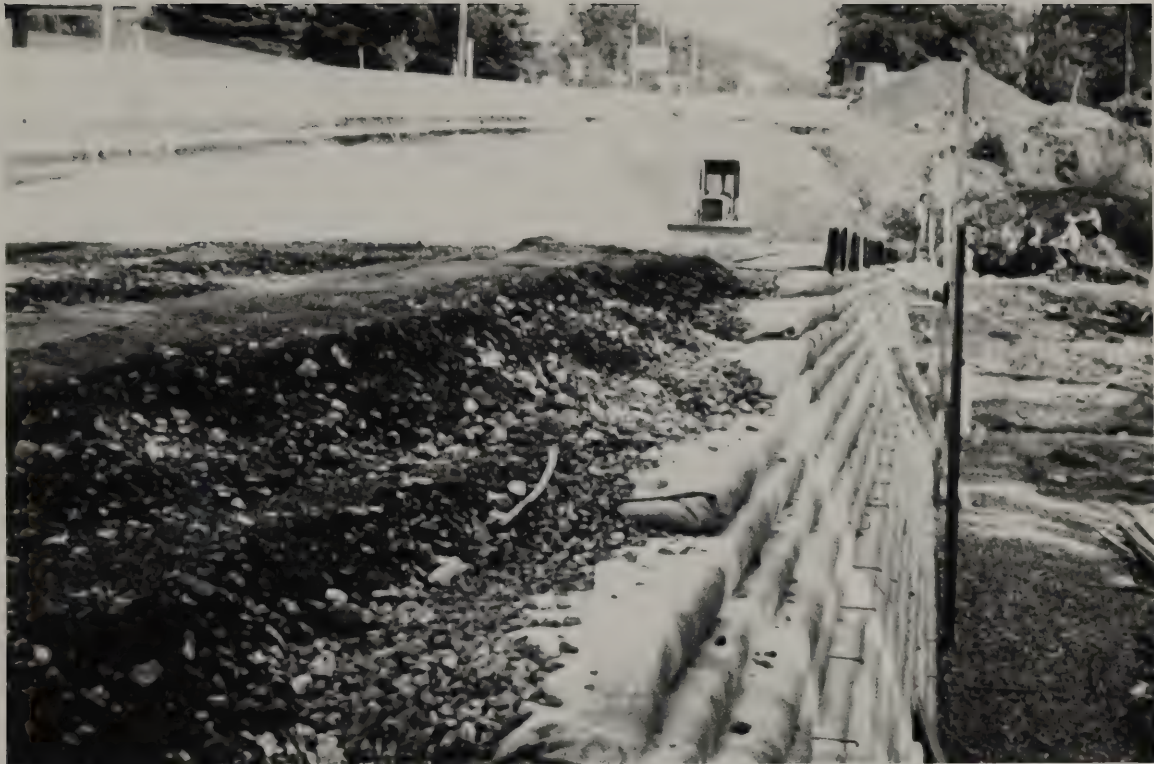
STEPPING THE LIFTS TO FOLLOW GRADE

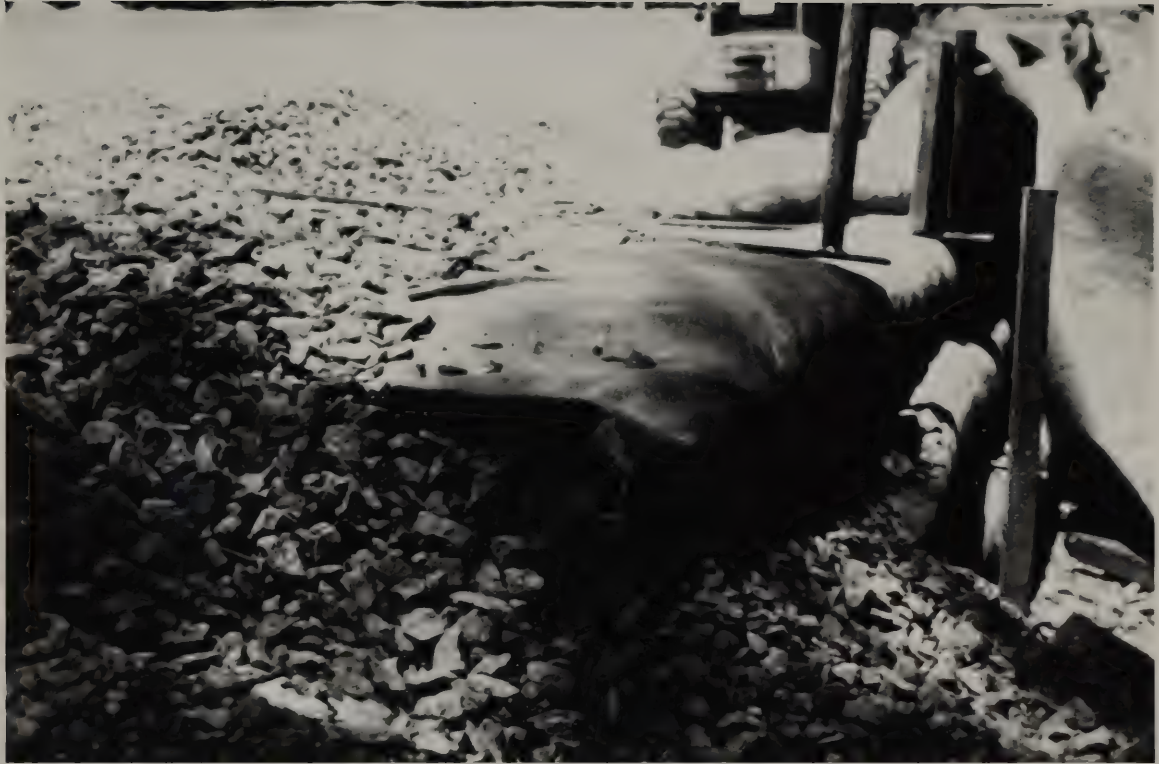
Compaction vibrated some stone fill out of the open ends of lower lifts. This loss of fill was prevented by folding the fabric to form a "bed corner." Figure 11. This figure also shows how the upper lifts were stepped to follow the grade of the road. At the south end of Wall A, each lift was folded to bend the wall back to meet the flatter existing slope, Figure 12. The north

END OF LIFT, UNCONFINED  
FIGURE 18

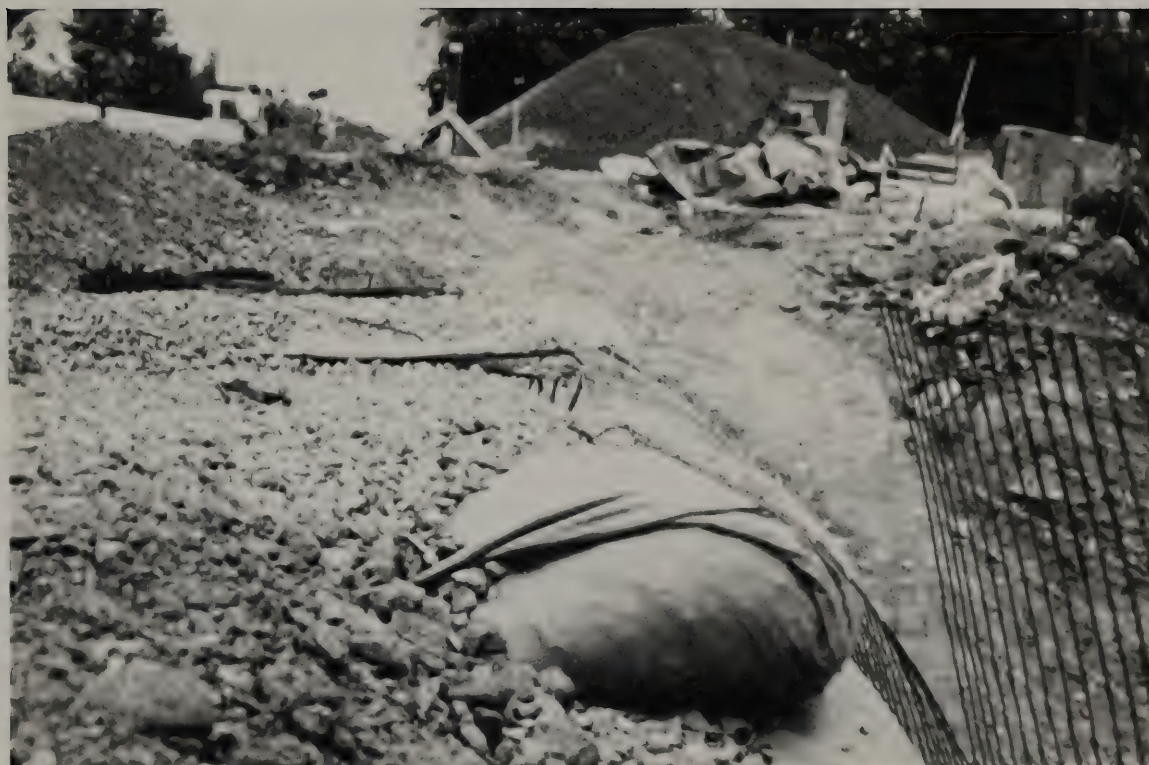
"BED CORNER" TO CONFINE LIFT  
FIGURE 19

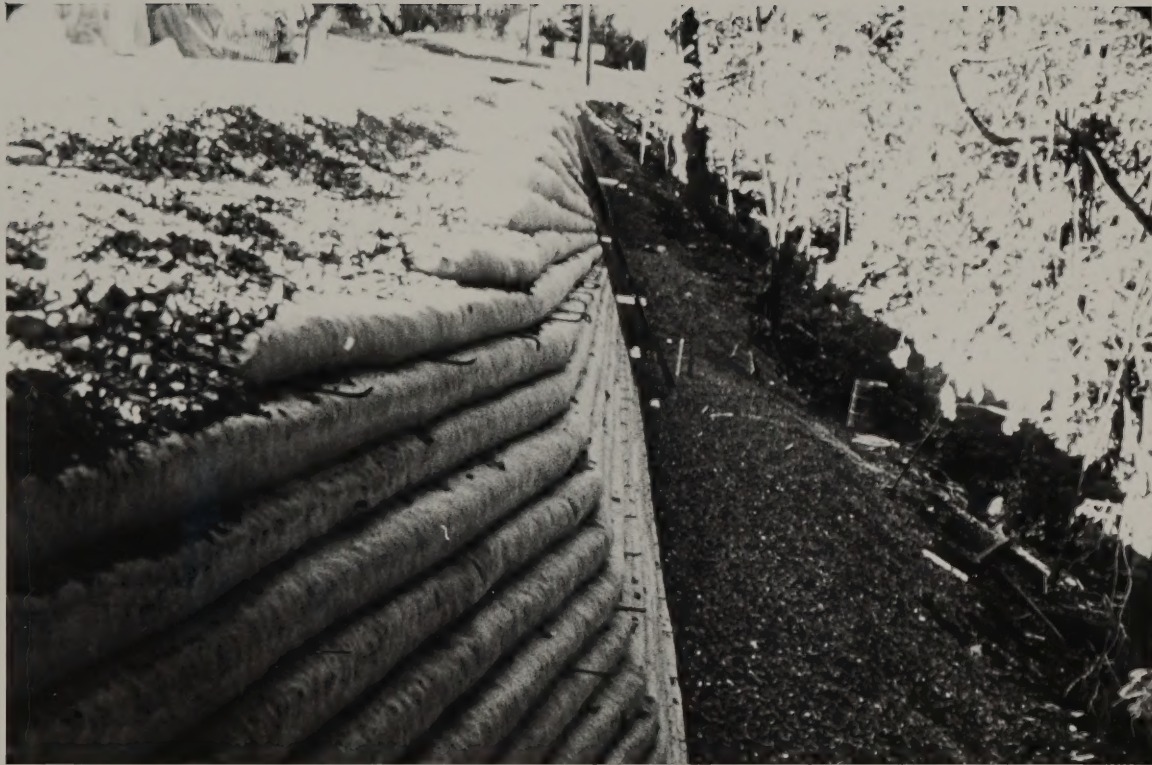
BENDING THE WALL TO MEET EXISTING SLOPE  
FIGURE 20
